Level III No Site Visit Reserve Study Report

For Fiscal Year Beginning January 1, 2026

Yodelin POA - Water System

Leavenworth, WA
October 8, 2025

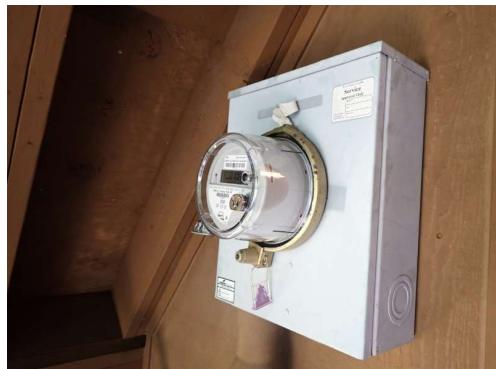
Electrical System - Repair/Replace

Location: At water system pump houses

Component History: No history reported, presumed to have been installed at time of 2006 water system upgrade

Generally, if installed without defect, there is no predictable basis to expect complete replacement of electrical system within the scope of this report therefore no reserve funding included.

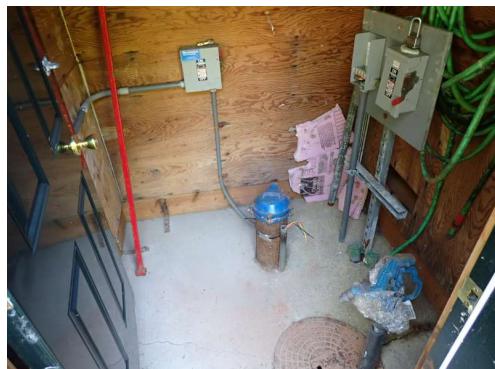
Submersible Well Pump - Replace - 2032		1 Each	@ \$1,350.00
Asset ID	7005	Asset Actual Cost	\$1,350.00
Category	Water System	Percent Replacement	100%
Placed in Service	January 2020	Future Cost	\$1,611.97
Useful Life	12		
Replacement Year	2032		
Remaining Life	6

Component History: 2006 at drilling of well, replaced 2020

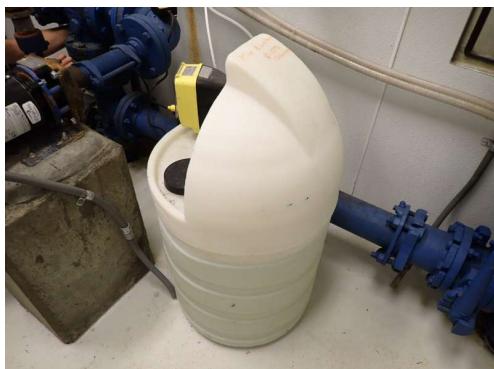
Chlorination System - Replace

Location: Within pump house off Stevens Road

Component History: Presumed original to ~ 2006 water system upgrades

Cost to replace system components generally falls below the reserve funding threshold therefore replace as needed through annual operating budget.

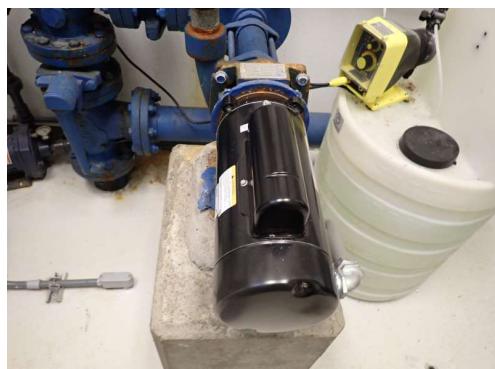
Booster Pumps - Replace - 2040		2 Each	@ \$2,600.00
Asset ID	7030	Asset Actual Cost	\$5,200.00
Category	Water System	Percent Replacement	100%
Placed in Service	January 2020	Future Cost	\$7,865.47
Useful Life	20		
Replacement Year	2040		
Remaining Life	14

Component History: Reportedly installed at time of ~ 2006 water system upgrade, replaced 2020

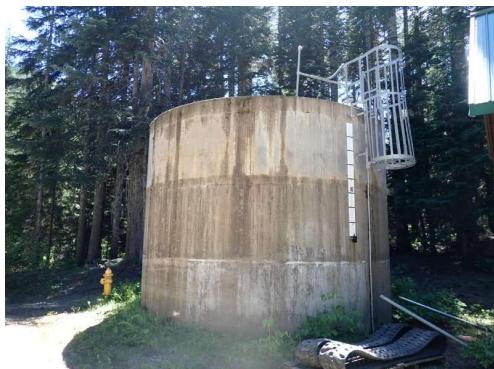
Water Tank - Replace - 2066

Asset ID	7035	1 Each	@ \$103,000.00
Placed in Service	January 2006	Asset Actual Cost	\$103,000.00
Category	Water System	Percent Replacement	100%
Useful Life	60	Future Cost	\$335,989.89
Replacement Year	2066		
Remaining Life	40

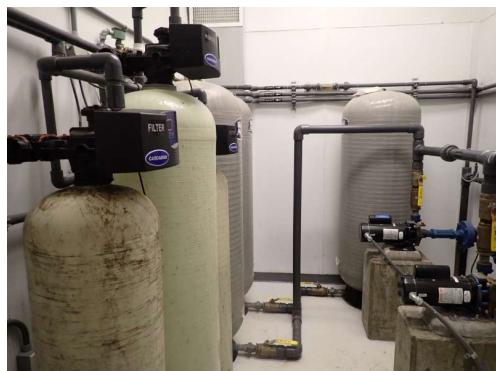
Expansion Tanks - Replace

Location: Within lower floor of pump house

Component History: Reportedly installed during 2006 water system upgrades

Cost to replace pressure tanks typically falls below the reserve funding threshold therefore replace as needed through annual operating budget.

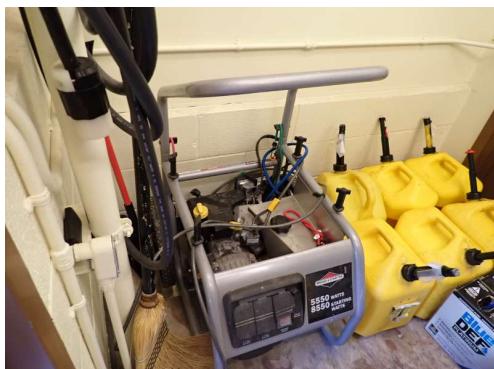
Generator - Replace - 2029

Component History: Reportedly original to 2006 water system upgrades, carburator repair 2025 \$200

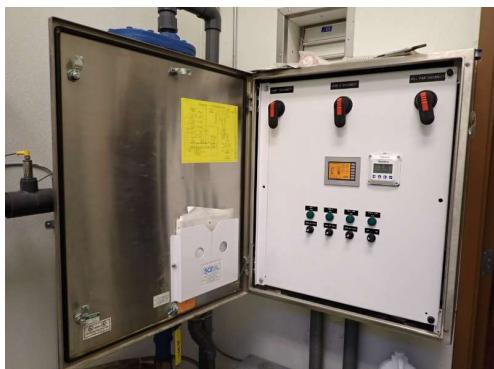
Telemetry/Control System - Replace - 2026

Asset ID	7050	1 Each	@ \$5,200.00
Category	Water System	Asset Actual Cost	\$5,200.00
Placed in Service	January 2006	Percent Replacement	100%
Useful Life	20	Future Cost	\$5,200.00
Replacement Year	2026		
Remaining Life	0

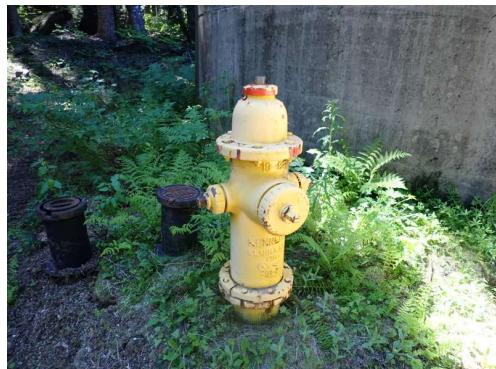
Fire Hydrant - Replace		1 Each
Asset ID	7055	Asset Actual Cost
Category	Water System	Percent Replacement
Placed in Service	January 2006	Future Cost
No Useful Life		100%

Location: Adjacent to water storage tank

Component History: Presumed to have been installed at time of ~ 2006 water system upgrades

When properly installed without any known defects, there is no predictable basis to anticipate complete replacement of commercial grade fire hydrant within the scope of this report, therefore no reserve funding included.

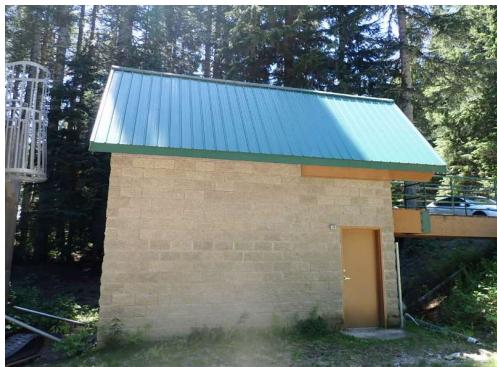
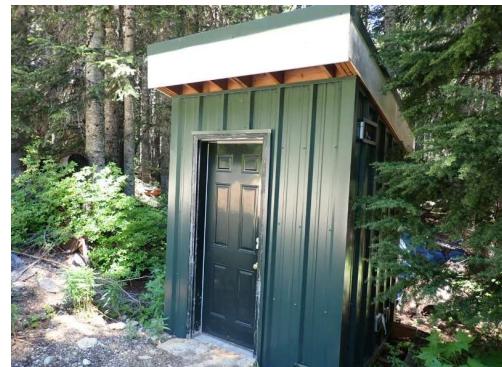
Pump/Well House Exteriors - Refurbish - 2036

Asset ID	7060	1 Allowance	@ \$6,000.00
		Asset Actual Cost	\$6,000.00
		Percent Replacement	100%
Category	Water System	Future Cost	\$8,063.50
Placed in Service	January 2006		
Useful Life	30		
Replacement Year	2036		
Remaining Life	10

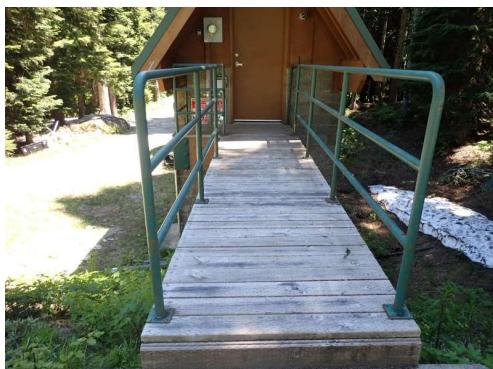
Pump House Wood Bridge - Replace - 2036

Asset ID	7065	110 GSF Asset Actual Cost Percent Replacement	@ \$36.00 \$3,960.00 100%
Category	Water System	Future Cost	\$5,321.91
Placed in Service	January 2006		
Useful Life	30		
Replacement Year	2036		
Remaining Life	10
