# **Level I – FULL Reserve Study Report**

## **For Fiscal Year Beginning January 1, 2025**

# **Yodelin POA - Water System**

**Leavenworth, WA**

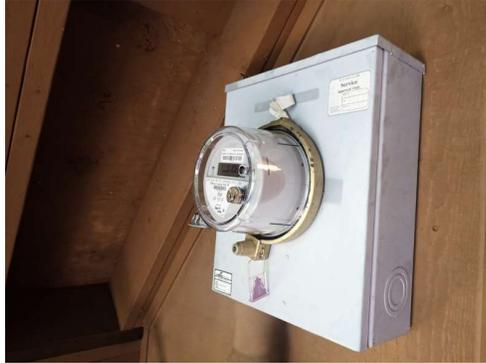
**Electrical System - Repair/Replace**

Location: At water system pump houses

Component History: No history reported, presumed to have been installed at time of 2006 water system upgrade

No problems reported of electrical system at the time of this report. Evaluation of electrical components is beyond the scope of a reserve study; if problems are suspected, consult with a qualified electrician immediately. Generally, if installed without defect, there is no predictable basis to expect complete replacement of electrical system within the scope of this report therefore no reserve funding included. No known defects reported by client.

Regularly inspect common area electrical panels and equipment. Contact a qualified electrician if breakers routinely trip or fuses regularly blow, or if you notice a sizzling sound or a burning odor. Ensure that electrical plugs near wet locations (restrooms, exterior building walls, outdoor parking garages, etc.) are Ground-Fault Circuit Interrupters (GFCI).

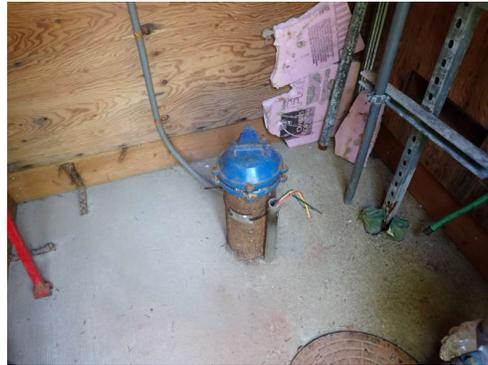
**Well Casing - Replace - 2081**

No problems reported of well casing(s) by client at the time of this report. Casing replacement is factored at 75 year intervals for financial planning purposes; it may be more cost effective to drill a new well rather than replace casing however it cannot be assumed that a new well will be a possibility therefore funding for casing replacement is a best practice. Cost can vary depending on a number of factors including depth of well therefore a middle range allowance has been included for the purposes of this report.

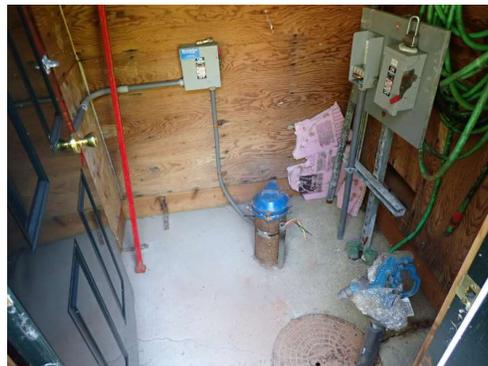
**Submersible Well Pump - Replace - 2032**

Component History: 2006 at drilling of well, replaced 2020

The useful life of submersible well pumps can vary greatly depending on a number of factors, however most communities replace pumps at 8-12 year intervals to maintain function. Cost allowances assume replacement of pump only; electrical and/or plumbing work may increase project cost but are unpredictable for the purposes of this report.

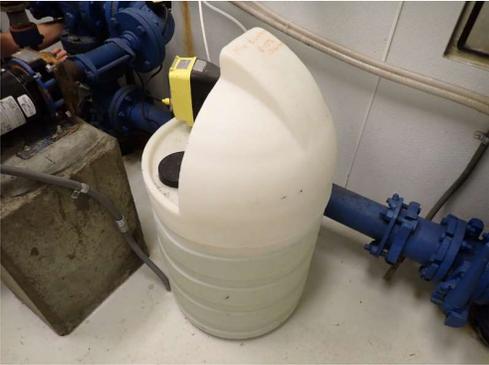
**Chlorination System - Replace**

Location: Within pump house off Stevens Road

Component History: Presumed original to ~ 2006 water system upgrades

Chlorination systems are typically basic systems consisting of a chemical feed pump and a storage tank for the chlorine. Cost to replace system components generally falls below the reserve funding threshold therefore replace as needed through annual operating budget.

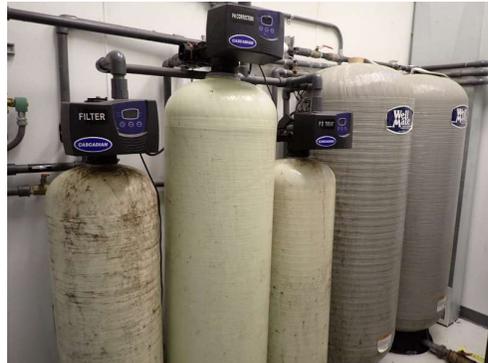
**Treatment System - Replace - 2036**

Water treatment systems are typically a simple system involving control heads on treatment tanks filled with filtration/treatment media. Plan to replace treatment system at 30 year intervals to maintain function; cost can vary widely based on system selected. Replace filtration/treatment media as needed. Replacement cycles vary based on each community and cost to replace media is projected to be too small to qualify for reserve funding.

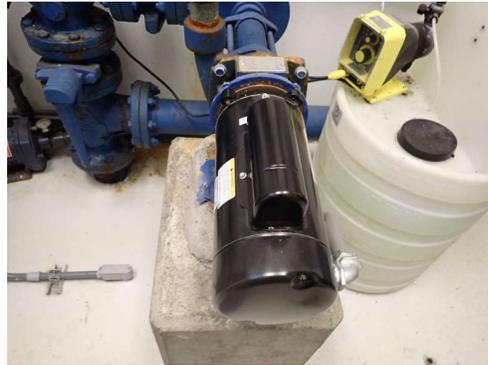
**Booster Pumps - Replace - 2040**

Component History: Reportedly installed at time of ~ 2006 water system upgrade, replaced 2020

The useful life of booster pumps can vary due to the mechanical nature of the equipment, however most communities replace booster pumps at 10-20 year intervals to maintain function. Cost can vary based on size and quality of pump. Cost allowances assume replacement of pump and basic electrical work to connect new equipment. Wide scale plumbing or electrical work may cause cost to increase significantly. Sometimes, pumps can be rebuilt rather than replaced.

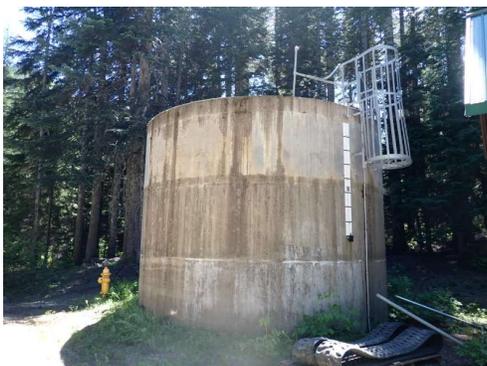
**Water Tank - Replace - 2066**

Concrete water storage tanks tend to have a prolonged useful life often ranging from 50-75 years. As routine maintenance inspect tank and clean regularly utilizing diver services (see separate component if applicable). Ensure ladder is secure (if present) and tank hatch closes securely to prevent debris from entering the tank and contaminating the water supply. Efflorescence, the white stains on the exterior of the tank left by water that has moved through the concrete and evaporated, is common at concrete tanks and can often be addressed by coating the interior of the tank. Coating cycles, if applicable, are handled separately within this report.

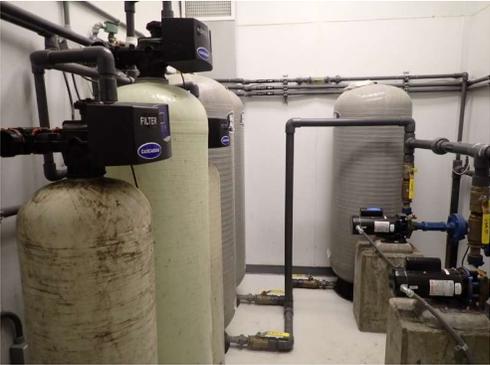
**Expansion Tanks - Replace**

Location: Within lower floor of pump house

Component History: Reportedly installed during 2006 water system upgrades

No problems reported of pressure tank(s) at the time of this report. The primary role of a pressure tank is to assist in regulating water pressure while providing instant access to well water without waiting for the well pump to activate. There are typically three types of pressure tanks; bladder tanks, diaphragm tanks and air over water tanks. Determination as to which type of tank is present at the association’s system is beyond the scope of a reserve study. Cost to replace pressure tank(s) typically falls below the reserve funding threshold therefore replace as needed through annual operating budget.

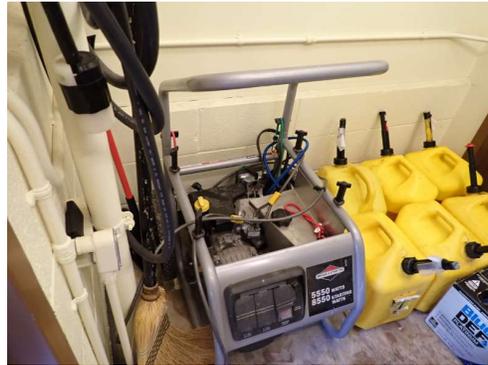
**Generator - Replace - 2025**

Component History: Reportedly original to 2006 water system upgrades, client reports need for replacement

Client reports generator needs replacement. Plan to replace generator at roughly 10-15 year intervals to maintain function. Cost can vary based on size and quality of equipment selected. Funding allowances assume replacement of generator and basic electrical connection of the new equipment; extensive electrical work may cause cost to increase significantly.

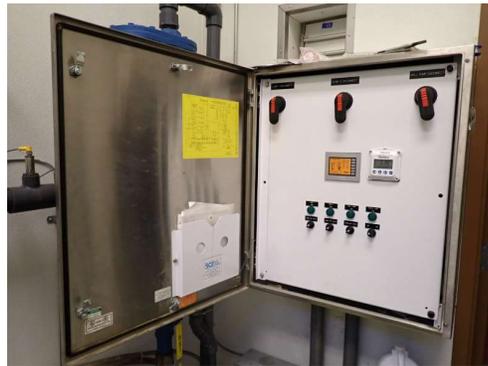
**Telemetry/Control System - Replace - 2026**

Replacement cycles for telemetry systems varies by community, however many communities replace/upgrade system at 10-20 year intervals to maintain function and take advantage of technological advancements. Cost can vary widely based on capabilities of system selected, therefore a middle range allowance has been used for the purposes of this report. Cost allowances include replacement of telemetry equipment only; electrical work, if any, may increase system cost.

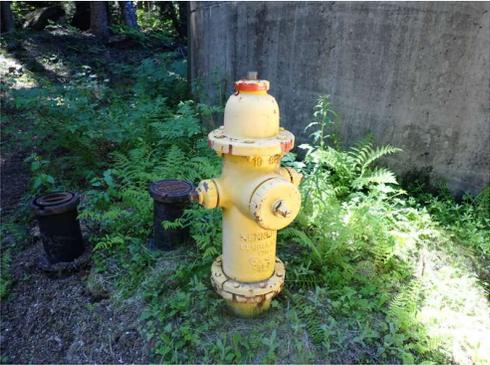
**Fire Hydrant - Replace**

Location: Adjacent to water storage tank

Component History: Presumed to have been installed at time of ~ 2006 water system upgrades

When properly installed without any known defects, there is no predictable basis to anticipate complete replacement of commercial grade fire hydrant within the scope of this report, therefore no reserve funding included. Inspect and test as required by local code utilizing operating funds. Repair or replace as needed through annual operating budget.

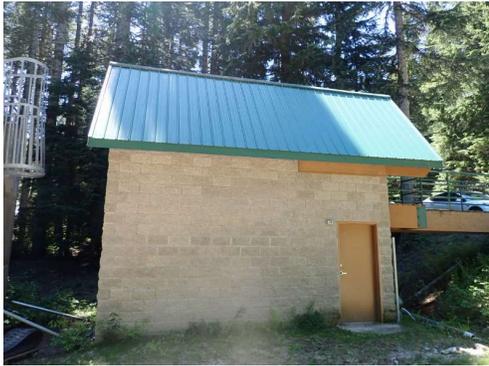
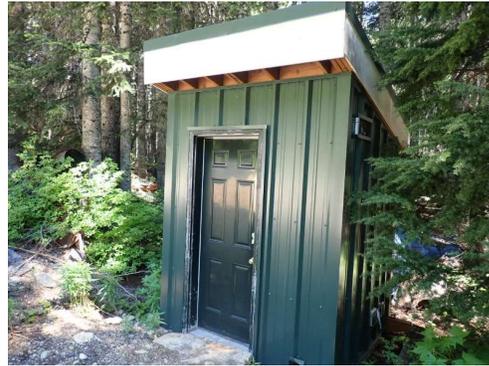
**Pump/Well House Exteriors - Refurbish - 2036**

Pump house featured concrete masonry unit (CMU) construction while well house was wood frame with metal siding. Both featured metal roofing. While there is no basis to expect complete replacement of pump or well houses within the scope of this report, it is reasonable to expect that periodic cycles of refurbishing will be required at exteriors. Projects may include siding repair/replacement, roof replacement, window/door replacement, lighting, etc. Cost can vary widely based on actual scope of work therefore a middle range allowance has been included for the purposes of this report. Cost to paint exterior is projected to be too small to qualify for reserve funding therefore paint as needed through annual operating budget.

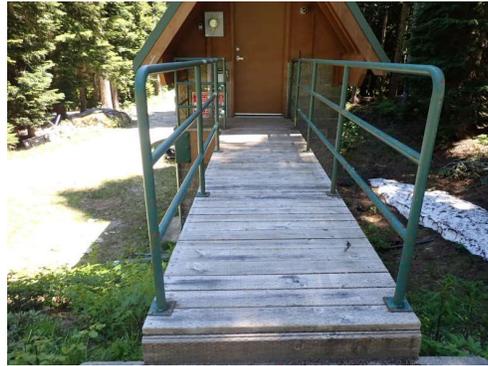
**Pump House Wood Bridge - Replace - 2036**

The average useful life of a wood deck/bridge ranges from 20 to 30 years depending on exposure, levels of maintenance, etc. Inspect and repair bridge as needed through the annual operating budget. Ensure railings are securely attached. Keep surface free of organic debris including leaves and moss and clean regularly. Consult with your vendor about options for improving traction during wet and/or freezing weather by utilizing a slip resistant paint product. Metal railings are projected to have a useful life which exceeds the scope of this report therefore funding allowances include replacement of wood bridge only.
